Non-Destructive Integrity Testing of Rock Reinforcement at the Sunrise Dam Mine in Western Australia

W. Hartman¹, L. Nienaber², B. Lecinq³, J. Higgs⁴ and D. Tongue⁴

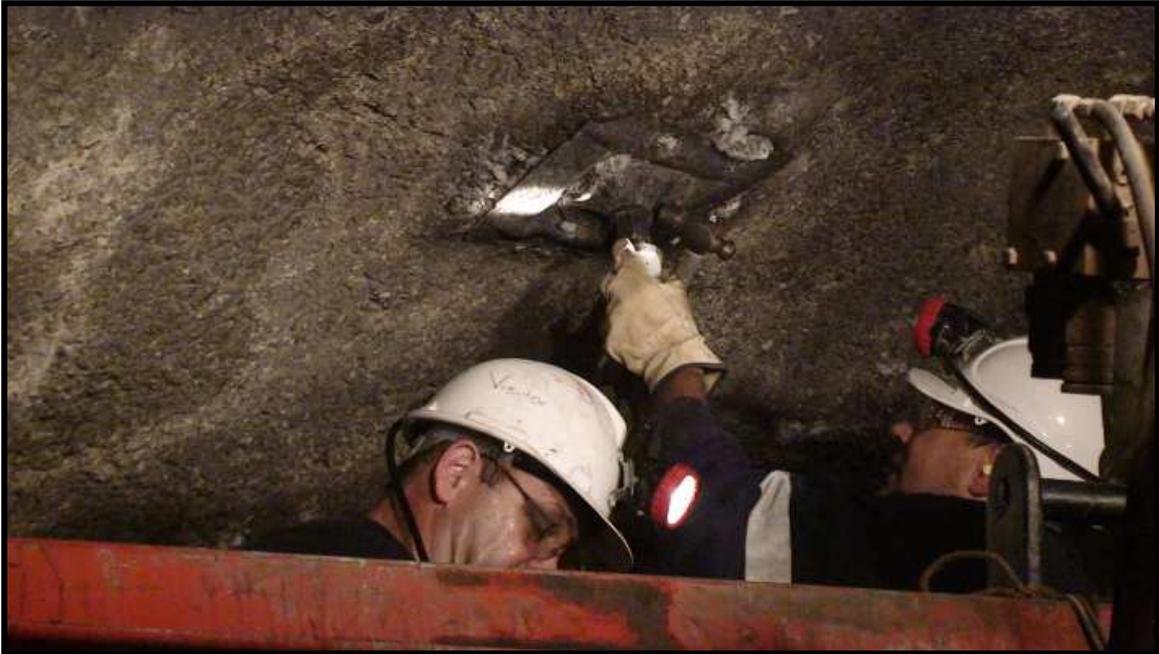
Figure 2 – Transducer and tapping device used to excite (generation of seismic signal) the element.

1. **A Toughbook / Note book** - this is used to collect data and providing power via a USB cable for the (Figure 1).
2. **Analogue/Digital Converter** - this converts the signal from the transducer into a digital format. The converter is soft wired to the transducer (Figure 1).
3. **Transducer** – *which is* held at the end of bolt (i.e. collar of hole – see Figure 2) during the test. A signal / pulse is obtained, which is generated by a small hammer.
4. **A small hammer or tapping device** (Figure 2) - This has to make contact against the plate of the bolt during the test.

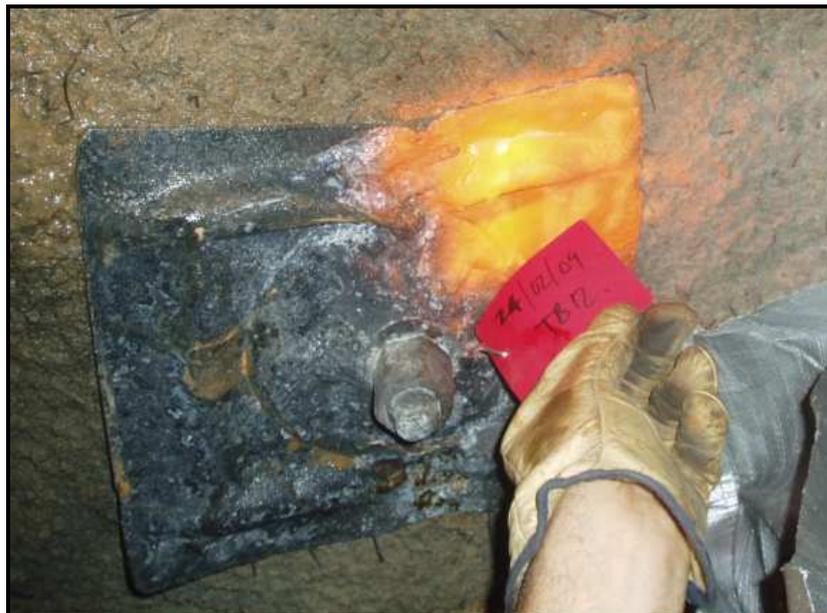
47 Bolts were tested (15 Posimix Bolts and 32 Cable bolts). Of the 15 Posimix bolts tested four showed signs of overstressing (i.e. bolts subject to ground deformation – see Figure 8) and of the 32 Cable Bolts tested three showed signs of overstressing.

Figure 8 – Testbolt 12 at the COS 1962 intersection show slight signs of deformation.

A reduction in load transfer or structural stiffness was noticed in a few of the tests and has been commented on as part of the overall results commentary. The reduction in load transfer between the rock/resin or grout /bolt can be caused by:-

- a) Poor mixing techniques,
- b) Insufficient resin for the hole size drilled or too large drill tip used
- c) Poor ground conditions – soft roof (although this could generally be discounted in this instance)
- d) Loss of bolt cross section due to corrosion and subsequent loss in load transfer.
