Development of a laboratory facility for testing shear performance of installed rock reinforcement tendons

**L Mahony
P Hagan
B Hebblewhite
W Hartman**

School of Mining Engineering, UNSW, Sydney, AUSTRALIA

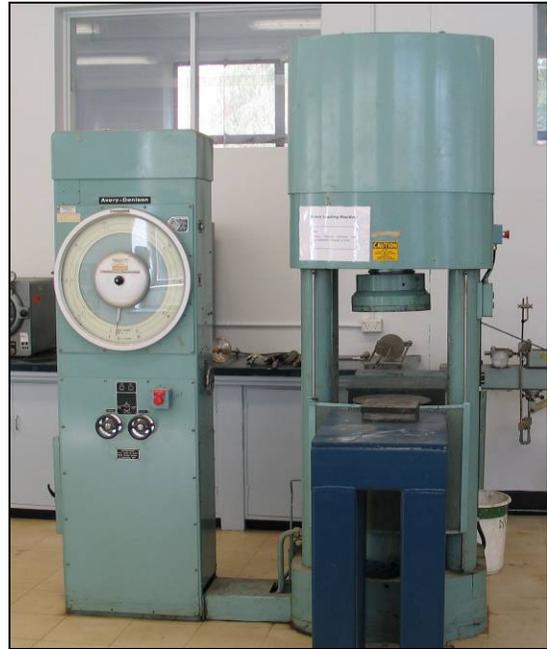
Figure 1 – Avery-Denison testing facility

An Avery-Denison compressive testing machine, previously used to test rock mass cylinders and cores (Figure 1) and capable of loads up to 3600 kN was converted into the required shear testing facility.

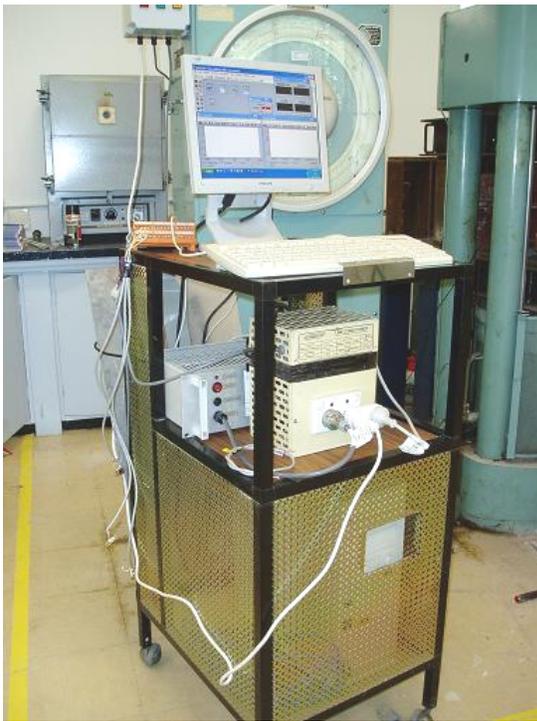
Figure 3 – Data Acquisition System (DAQ)

A data acquisition system (DAQ) was introduced within the shear testing facility. This DAQ consists of a high frequency multi-channel monitoring system capable of measuring multiple arrays of 64 channels (Figure 3).

The system is based on a personal computer and DASyLab software. Sampling rates can be taken at up to 1,000 readings per

second with a typical experiment containing between 5,000 and 10,000 data sets. The DAQ was configured to record the voltage output of the pressure transducers from two channels and up to three channels for displacement readings from the LVDT transducers. The DAQ is able to provide the data to create load versus displacement curves (shear and axial) and allow accurate calculations of loading rates within each test.

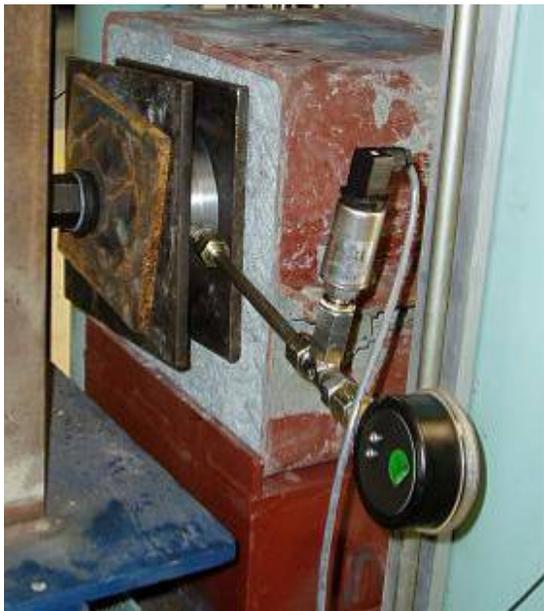
Figure 4 – Application of the hydraulic load cell and pressure transducer system

Pressure transducers introduced within the testing facility record the pressure applied by the piston onto the reinforced sample (later in the testing program an additional pressure transducer was required to measure the axial load that was induced in the bolt between the face plate and concrete surface). This pressure transducer, based on strain gauge technology consisting of a one piece stainless steel body, has a capacity of 400 bar and provides an output of 0 to 5 volts. The hydraulic load cell (with the installed pressure transducer positioned within the two steel plates prior to testing) can be seen below in Figure 4.

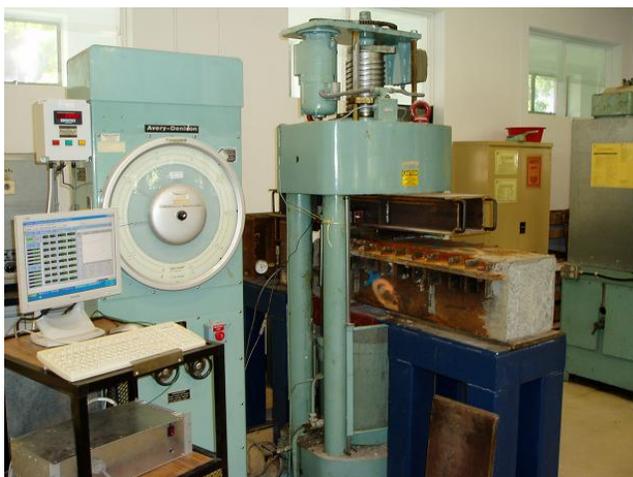
Figure 5 – Shear testing facility

The final set-up of the shear testing facility can be seen below in Figure 5. Figure 6 displays the dimensions of the installed rock bolt in the rock mass and the strain gauge locations, relative to the shear plane.

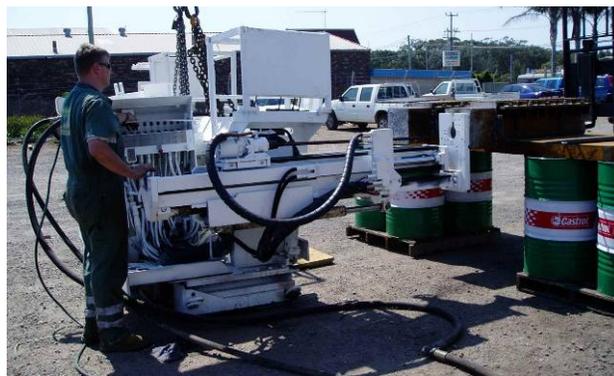
Figure 7 – Drilling borehole in concrete sample 1

Installation of the reinforcing elements was undertaken by an ARO roof bolter, commonly used in underground coalmines throughout the world (Figure 7 and 8). Using a roof bolter to install the reinforcing elements raised minor issues in the repeatability of installation practices with variations in the borehole size and applied pre-tension across some of the reinforced samples.

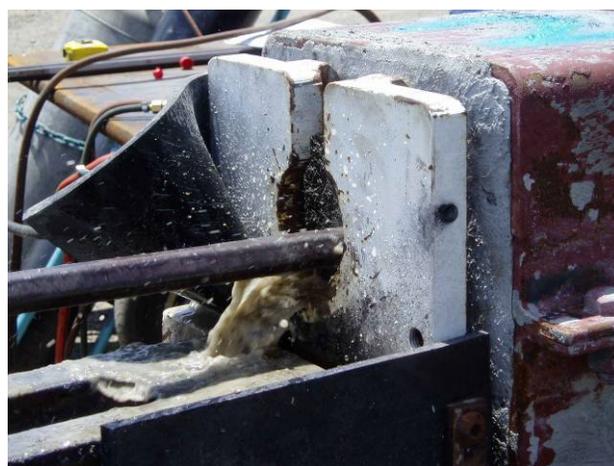
Figure 8 – Drilling borehole in concrete sample 2

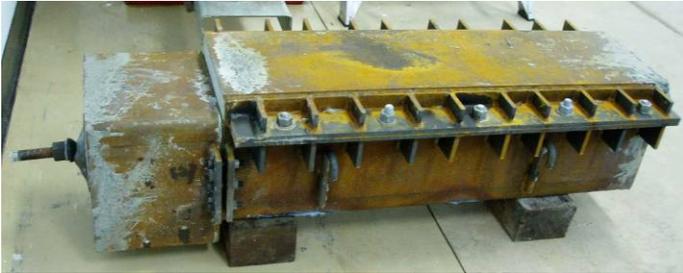
Figure 9 – Reinforced sample prior to testing

Once the samples were drilled and reinforced they were transported back to the laboratory ready for testing and analysis (Figure 9).

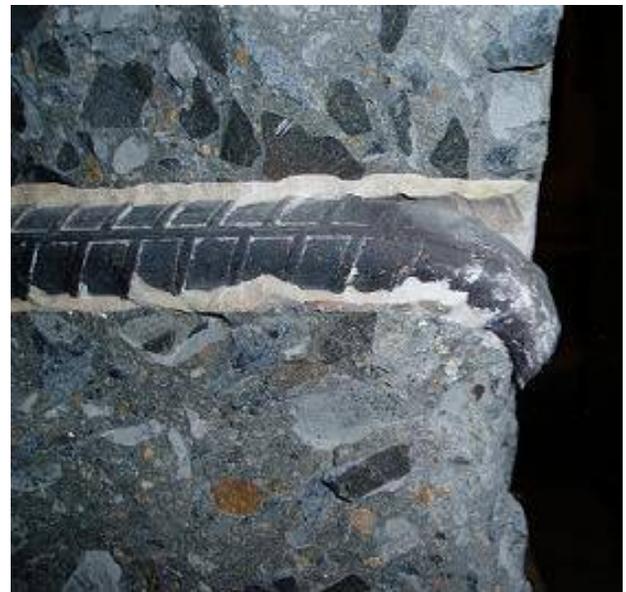
Figure 11 – Side profile of failed rock bolt subject to an applied shear load

The reinforced samples confined with a faceplate and nut at the collar of the borehole all failed at or above the ultimate tensile strength of the rock bolt itself. Figure 11 shows the side profile of a failed rock bolt.

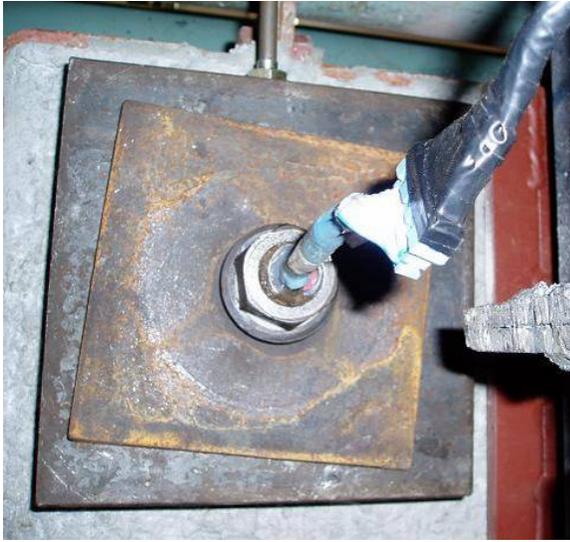
Figure 12 – Connection of strain-gauged rock bolt to DAQ

A preliminary series of tests were conducted using strain-gauged bolts, to assess the load distribution away from the shear plane. Unfortunately, initial problems were encountered with installation and orientation of the bolts and gauge alignment. The strain-gauged bolts were connected to the DAQ system as shown below in Figure 12.

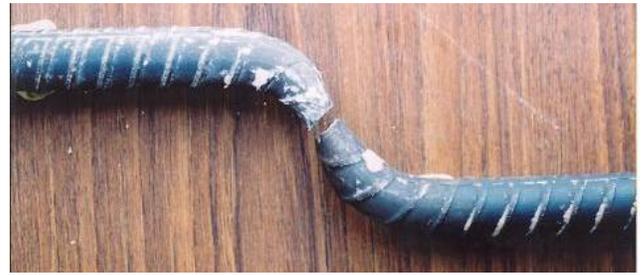
Figure 14 – Side profile of a typically failed reinforcing element subjected to a shear load

All the reinforcing elements that failed due to an applied shear load, did so in a ductile manner. This final ductile failure of the rock bolt occurred between the two plastic hinges (bending regions) that were formed due to the shear displacement of the two concrete blocks (where bending moment is greatest). Between these two hinges, the reinforcing element was subject to an axial load causing the element to fail axially, in tension (hence the bolt failing at shear loads well in excess of the steel shear strength), see Figure 14.

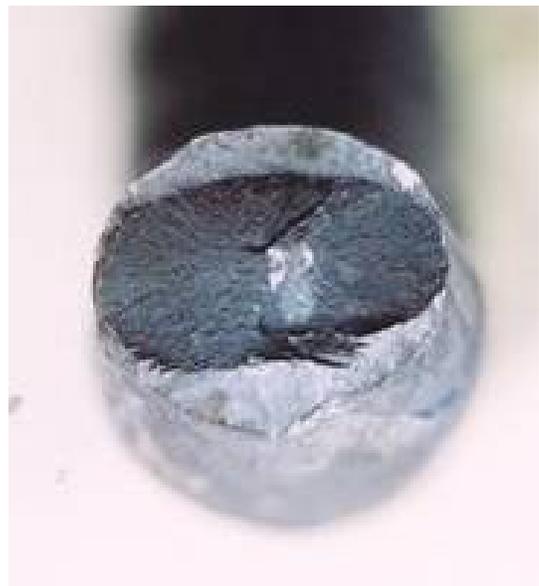
Figure 15 – Typical end profile of a failed reinforcing element subjected to a shear load

Inspection of the failed surface of the reinforcing element confirmed the failure mechanism as being a typical ductile bending, necking and then tensile failure. The failure initiated in the centre of the necked region with the crack, then progressed laterally towards the edge of the element in the area known as the radial zone. The fracture is then completed via a shear lip on the outer extremities of the element. A reinforcing element that is subject to a pure axial load creates a symmetrical shear lip around the outer edge of the failed rock bolt section, whereas the shear lip in the failed element subject to a shear load creates a more ellipsoid shape, engaging at the upper and lower section of the element (Figure 15). The shear lip is negligible at the sides of the element where the applied shear load is perpendicular to the element.

The development of this unique shear lip can be due to the final rupture of the rock bolt occurring at the ends where maximum stress is located in this section of the reinforcing element. When a shear load is applied to the element, the greatest stress within the rock bolt is located in the same plane as the applied load where the element is subjected to a tensile and/or compressive stress at either extremity. This final rupture of the element due to the shear lip occurs predominately in the same plane where the shear load is applied, compared to the uniform smooth annular area formed adjacent to the free-surface of the element when subjected to a pure axial load.
