NON DESTRUCTIVE INTEGRITY TESTING OF ROCK REINFORCEMENT ELEMENTS IN AUSTRALIAN MINES

ABSTRACT: Non-destructive testing, used to study the integrity of the bolting systems in underground mining and civil construction industries, as an alternative method to the current hydraulic pull testing practice, is described. Non-destructive tests were carried out on a total of 227 bolts, comprising 89 rebar type bolts, 124 cable bolts and 14 splitsets were tested in four mines across Australia. The purpose of these tests was to confirm the validity of the testing methodology for rock reinforcement systems used in mines and provide reassurance on bolt's integrity, which could have been compromised during installation or affected by in-situ aggressive conditions causing corrosion. A complex stress wave analysis package, based on the processing of clear seismic signals imparted into the rock reinforcement element, was used. The seismic signals are processed by "Fourier Transform" into various criteria, which can be used to produce models of the elements, such as mechanical admittance, frequency spectra and velocity. These components are then used in the final modeling of the rock reinforcement e

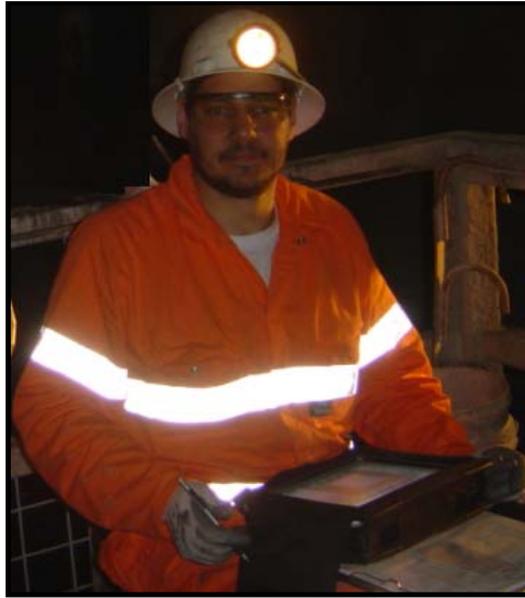
1. *A Toughbook / Notebook* - this is used to collect data and providing power via a USB cable for the (see Figure 1).

Figure 1 - Notebook in operation (by Wouter Hartman) at the Fosterville Underground Gold Mine.

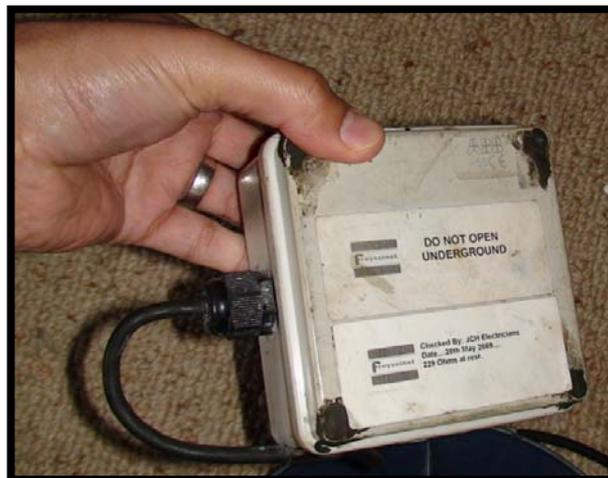
2. *Analogue/Digital Converter encased in closed unit* - this converts the signal from the transducer into a digital format. The converter is soft wired to the transducer (see Figure 2).

Figure 2 - Analogue/Digital Converter encased in closed unit for coal mine operations

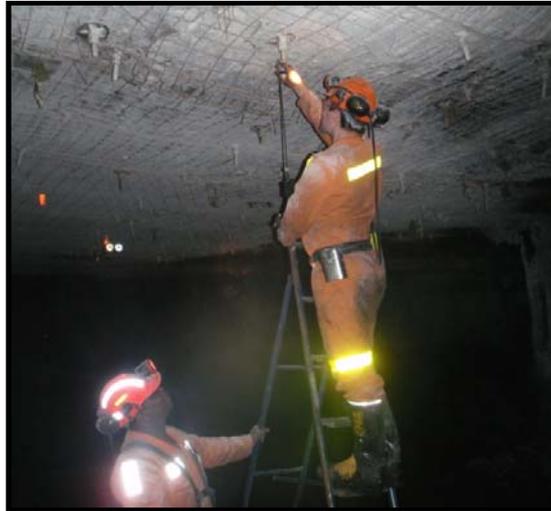
3. **Transducer** – which is held at the end of bolt (i.e. collar of hole – see Figure 3) during the test. A signal / pulse is obtained, which is generated by a small hammer.

Figure 3 - Photo showing transducer (vertical) held at the end of bolt (i.e. collar of hole) at Mandalong Coal Mine

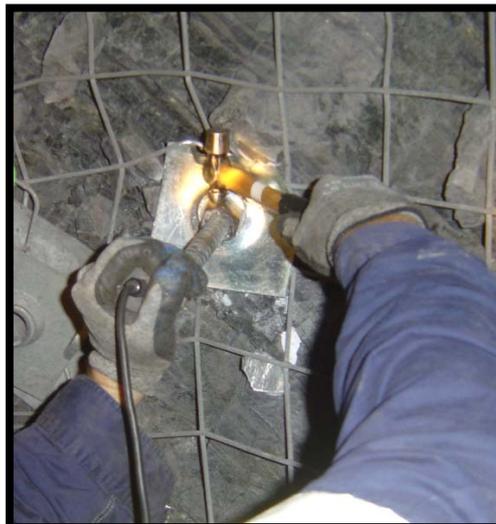
4. **A small hammer or tapping device** (see Figure 4) - This has to make contact against the plate or nut of the bolt during the test.

Figure 4 - Photo showing tapping device that is used to make contact with the nut of resin bolt.
