# Performance of Rock Reinforcement Elements subject to Shear Loading

*Wouter Hartman*  
*Senior Geotechnical Engineer*

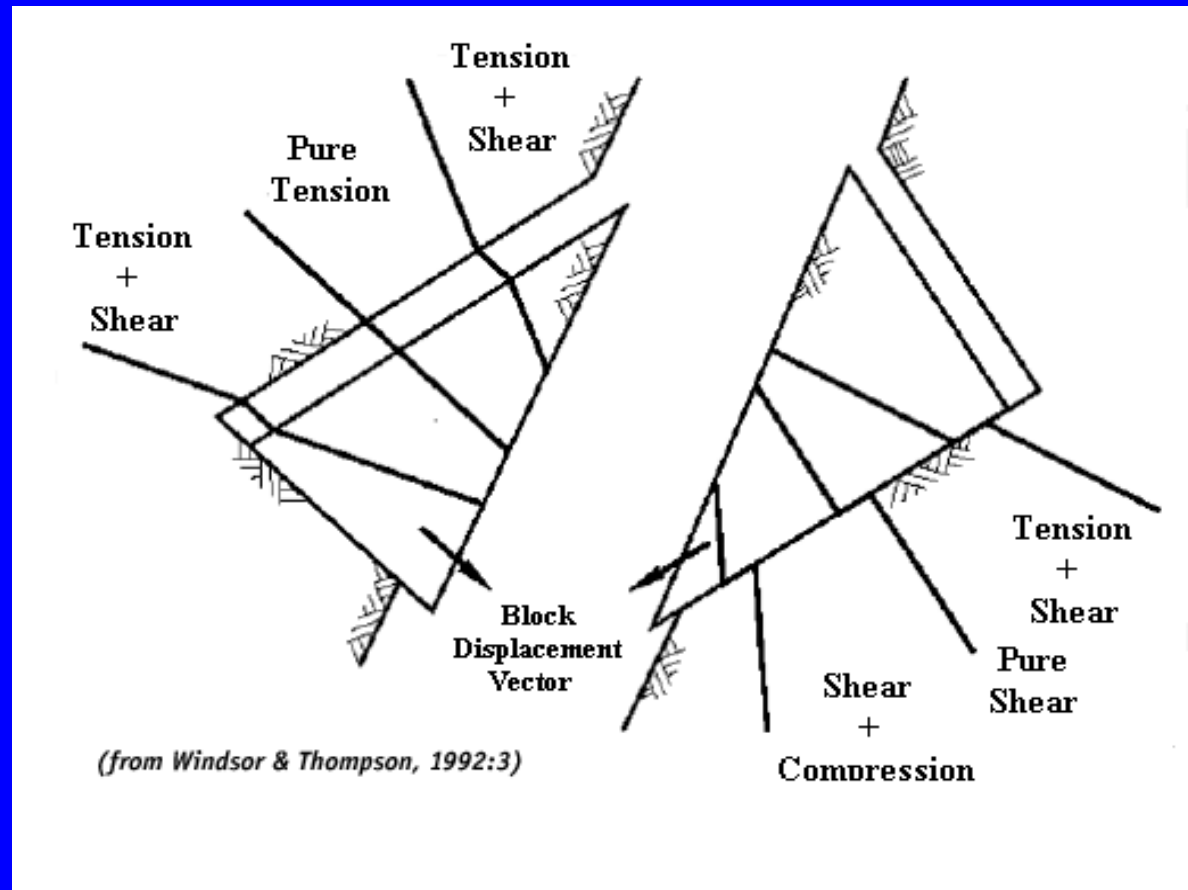
- Different mechanical behaviour depends on the reinforcement intersecting a discontinuity which opens or one which remains closed during block displacement

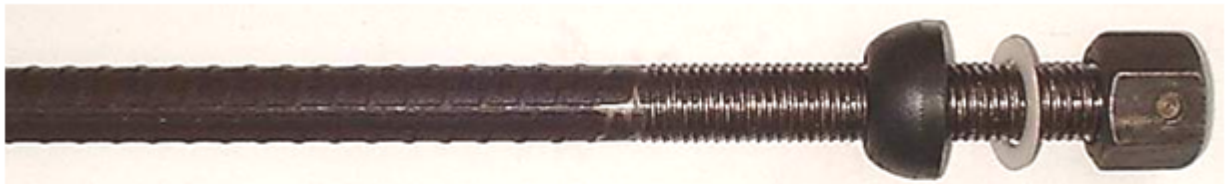
Jennmar JBX High Tensile Roofbolt (Jennmar, 2004)

Summary of mechanical and physical properties for Jennmar JBX Roofbolt

Typical Yield Strength	240kN	<b>~ 655 MPa</b>
Typical Ultimate Tensile Strength	335kN	<b>~ 914 MPa</b>
Typical Elongation to Fracture	19-20%	
Thread	24mm cold rolled, 150mm length I.S.O. M24, 3 Pitch	
Nut	Hot Forged	
<b>Bolt length</b>	<b>1.2m</b>	
<b>Bolt Diameter</b>	<b>21.6mm</b>

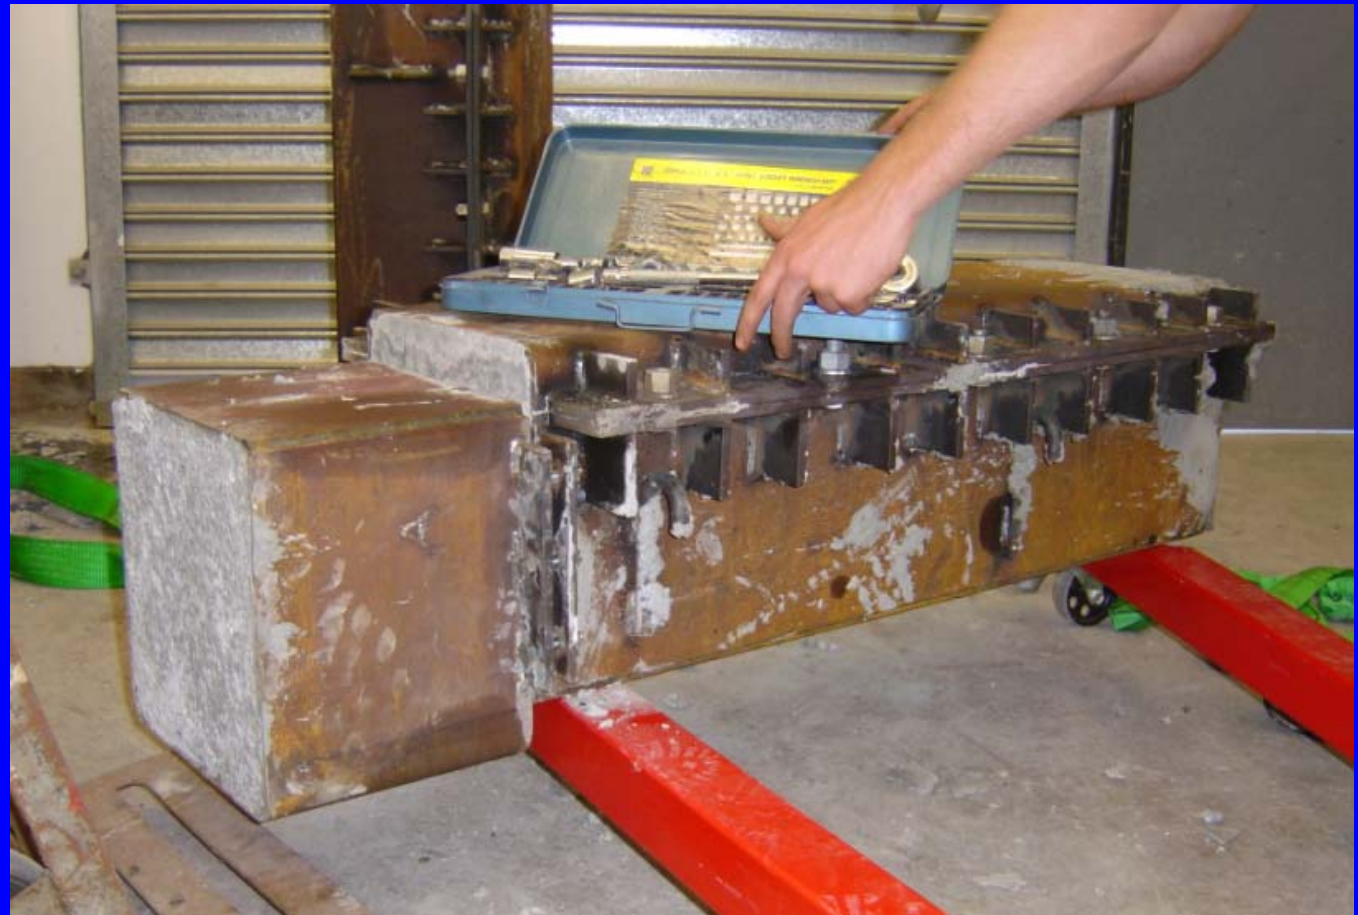
# Laboratory Rock Mass (concrete) Steel Contained

Concrete Properties

$E = 32.4 \text{ GPa}$
